Via Email: MBlock@catholicmutual.org

July 1, 2013

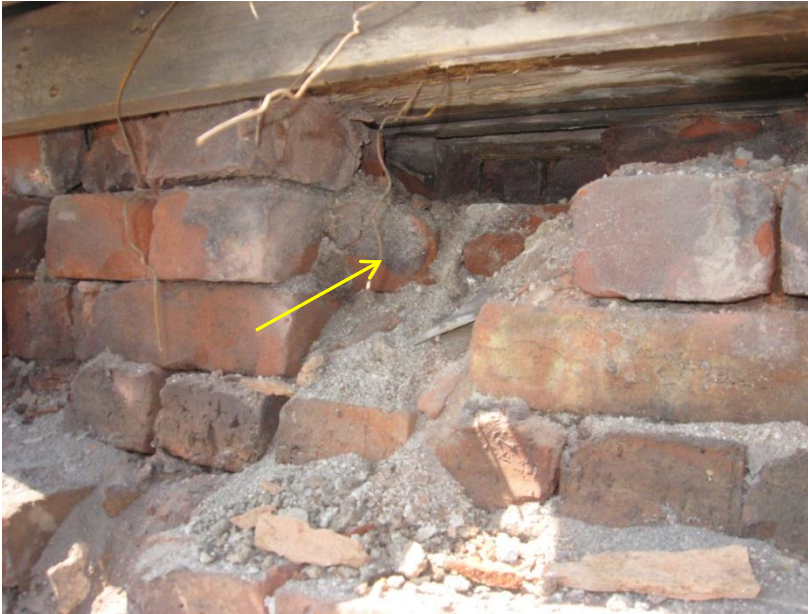
Figure 9. Backup brick masonry loose and easily removed by hand (arrow).

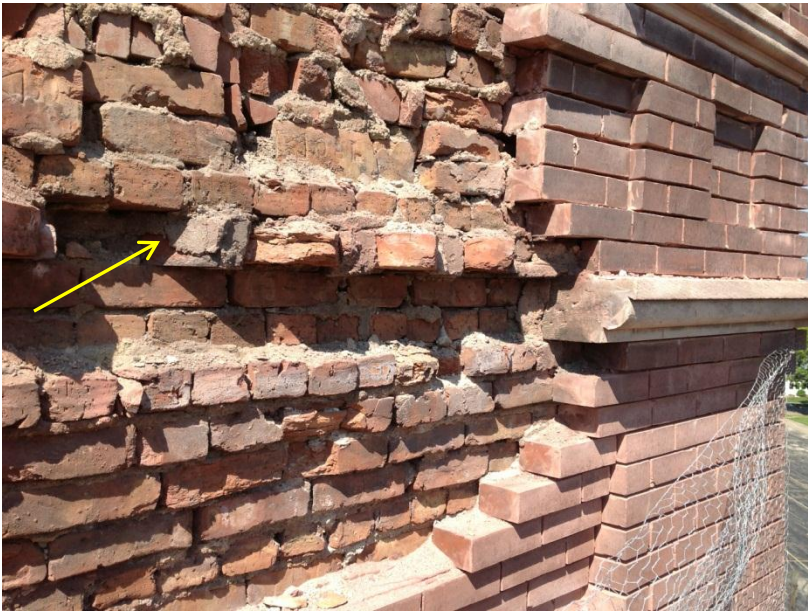
Figure 10. Note no evidence of metal ties in backup brick. Course of diagonal header bricks shown by arrow.

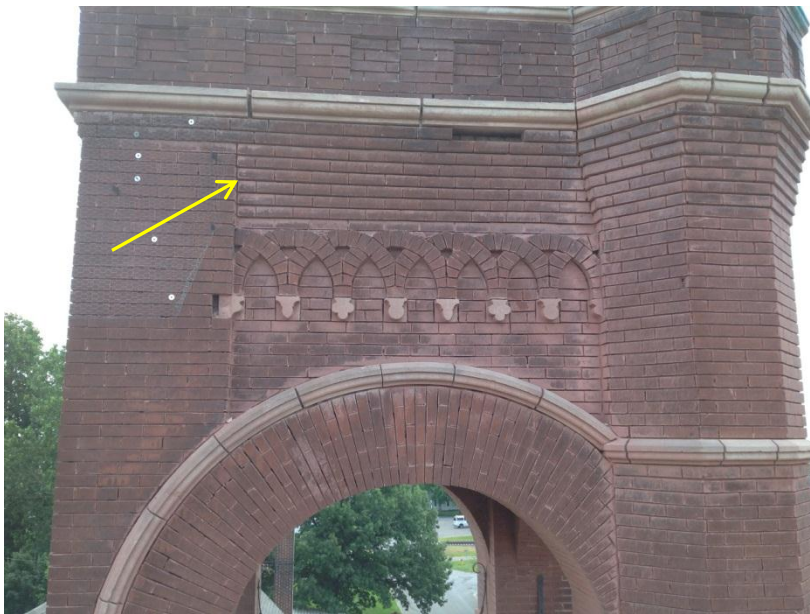
Figure 14. Overall view of west elevation of bell tower. Joints in stepped out portion of brick masonry (arrow) were ground out. Note missing bricks under limestone water table.

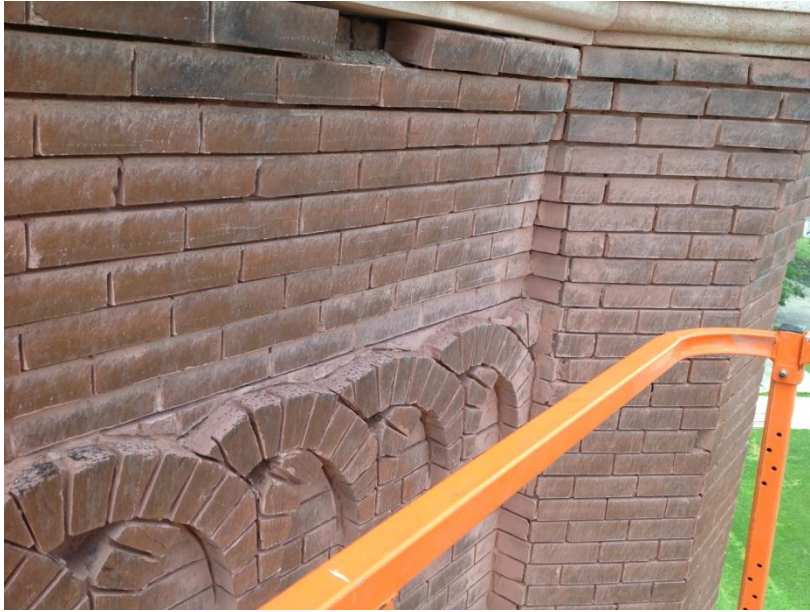
Figure 15. Close up view of stepped out portion of masonry showing profile and removed brick.

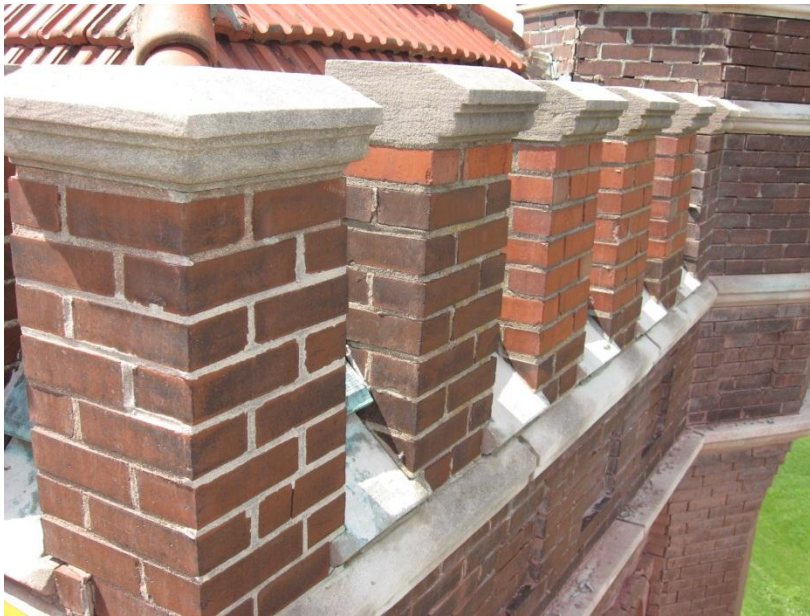
Figure 16. Battlement on west elevation. Note lighter colored bricks indicative of previous repairs.

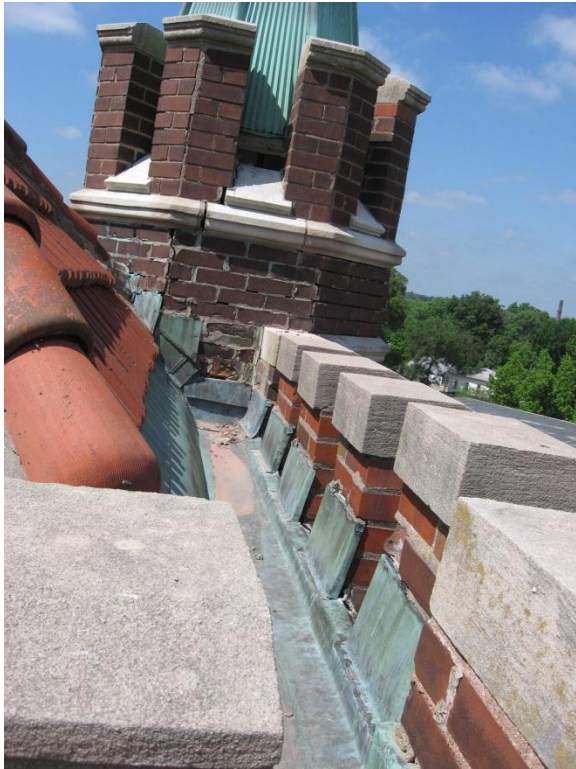
Figure 17. Copper flashing on backside of west elevation battlement.

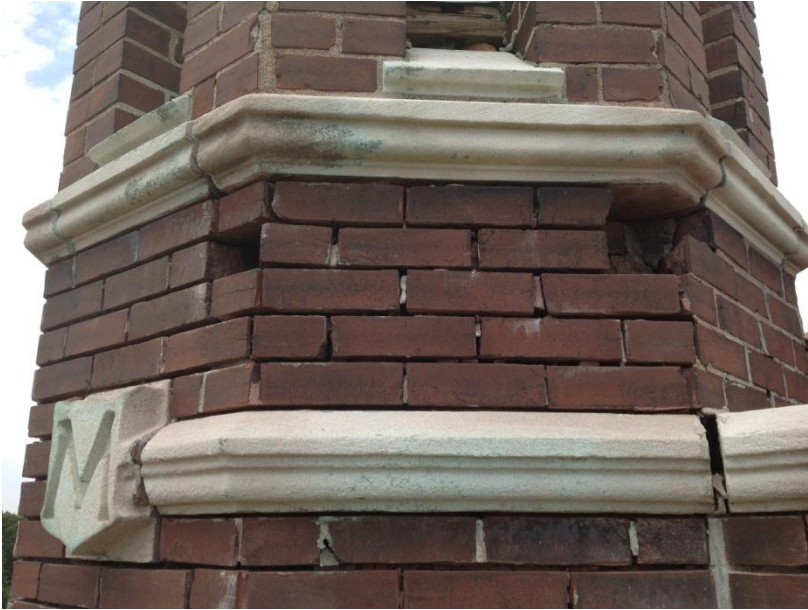
Figure 23. Removed face brick on turret below steeple. Backup brick also was loose and unsound at these locations.

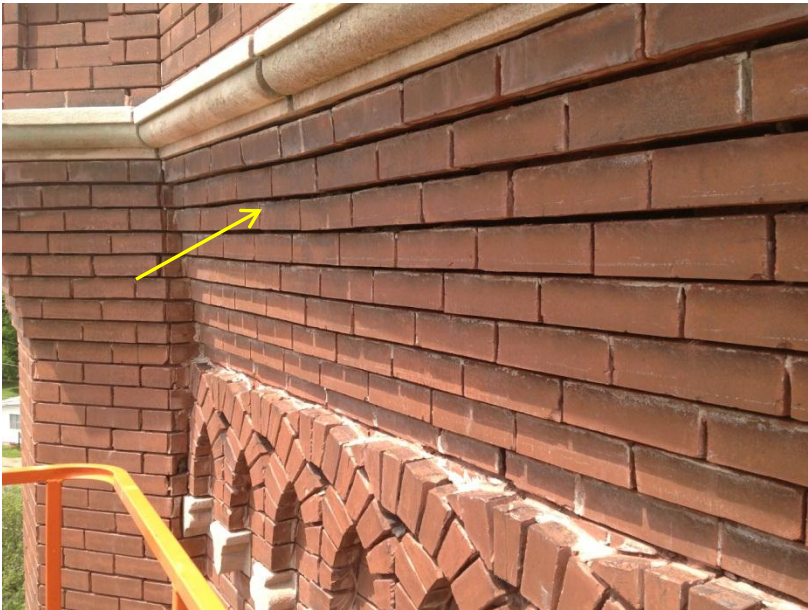
Figure 24. Stepped out portion of face brick on south elevation. Note deflection at loose brick (arrow).

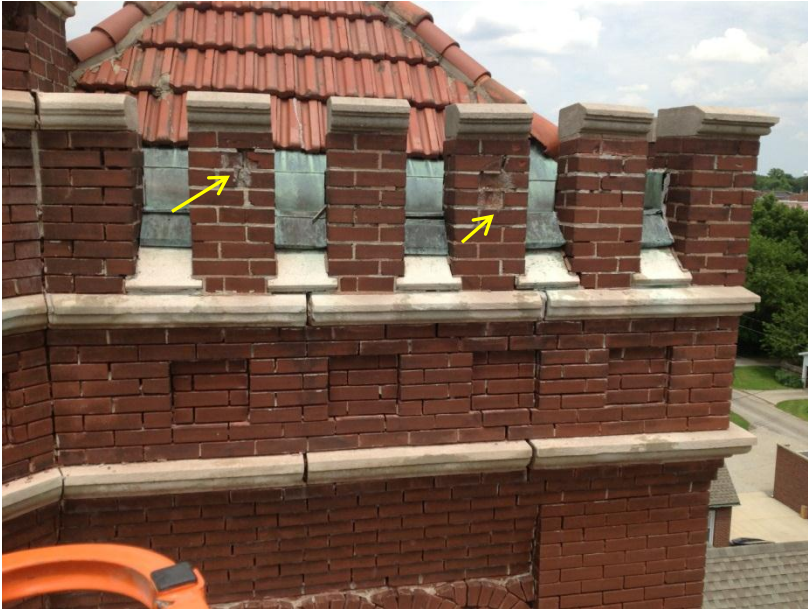
Figure 25. South elevation battlement. Note some loose pieces of masonry had been removed (arrows).

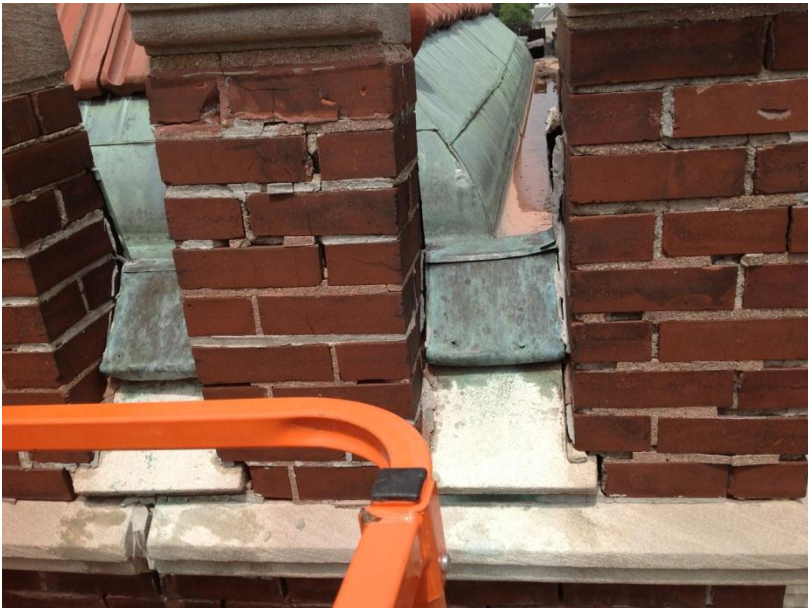
Figure 26. Copper flashing behind battlement, south elevation of bell tower.
